Specialty Manufacturing, Inc.

Technical Bulletin

REPLACMENT PROCEDURE:

4 AMP FUSE WITHIN 4" AND 6" TALL STROBE LIGHTS

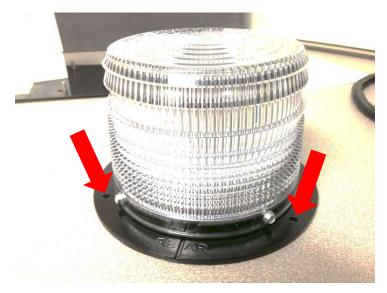
Figure S.1: Two of the four mounting screws are not pictured, they are on the opposite side of the strobe light.

2) Remove: 4 mounting screws on the exterior base of the strobe light. (See figure S.1.)

3) Remove: The strobe light from the vehicle. Leave the wires on the strobe light as long as possible for factory fault analysis.
